ASSESSMENT AND REPAIR OF DISTRESSED KILN PIERS IN A CEMENT MANUFACTURING PLANT

Abul K. Azad* and Fahd H. Dakhil

Saudi Cement Company Dammam, Saudi Arabia

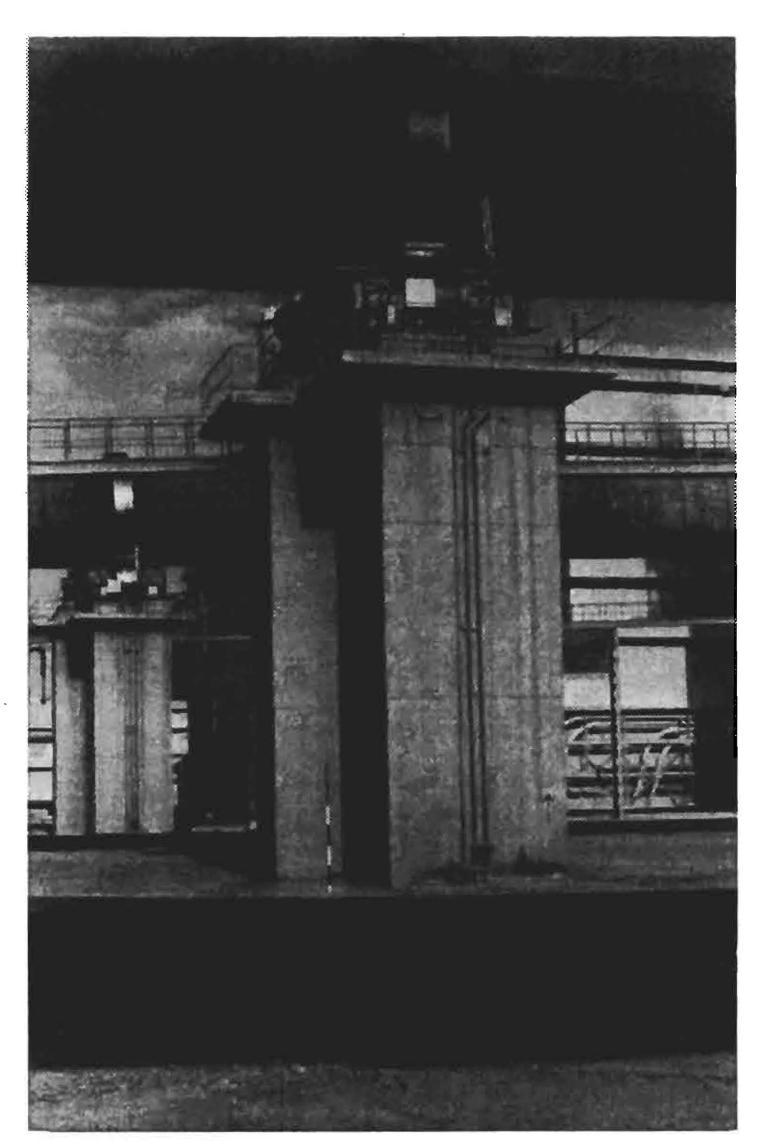
Figure 1. A View of the Kiln and the Supporting Pier.

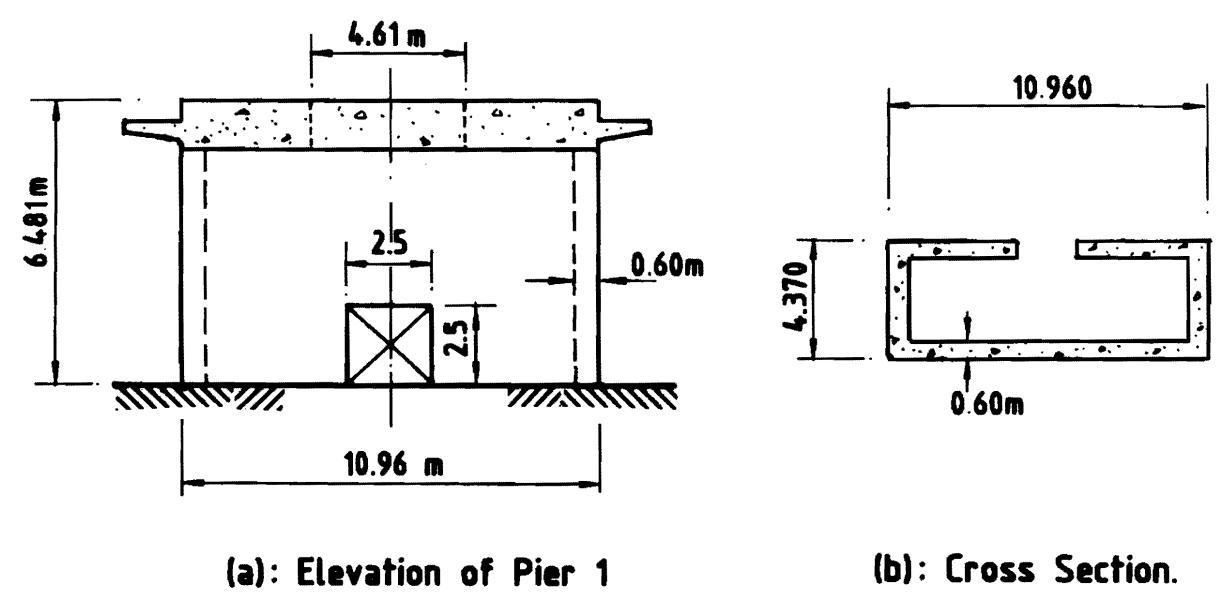
A typical pier is a hollow box-type section with an opening of 2.5×2.5 m at the ground level for access to the inside. The piers and their cross sections vary in shape and sizes, a representative one (Pier 1) is being shown in Figure 2. The 600 mm thick wall is orthotropically reinforced with vertical and horizontal reinforcement at each face. The top of each pier is covered by a 1500 mm thick RC slab built monolithically with the pier. This slab supports the kiln rollers and the necessary mechanical and electrical installations and equipment.

Figure 2. Pier 1: Elevation and Cross-section.

in Figure 2 was used. For torsional shear stresses in the walls, the cross section was treated as a thin-walled open section, due to the presence of a large hole of 2.5 m width in a longer side. The presence of this hole may not fully transform the closed-box section to an open one, because of the size, but this assumption is conservative, as it significantly reduces the torsional strength at this section. The cross section at the hole was considered to compute the maximum shear stress under the combined action of shear and torsion.

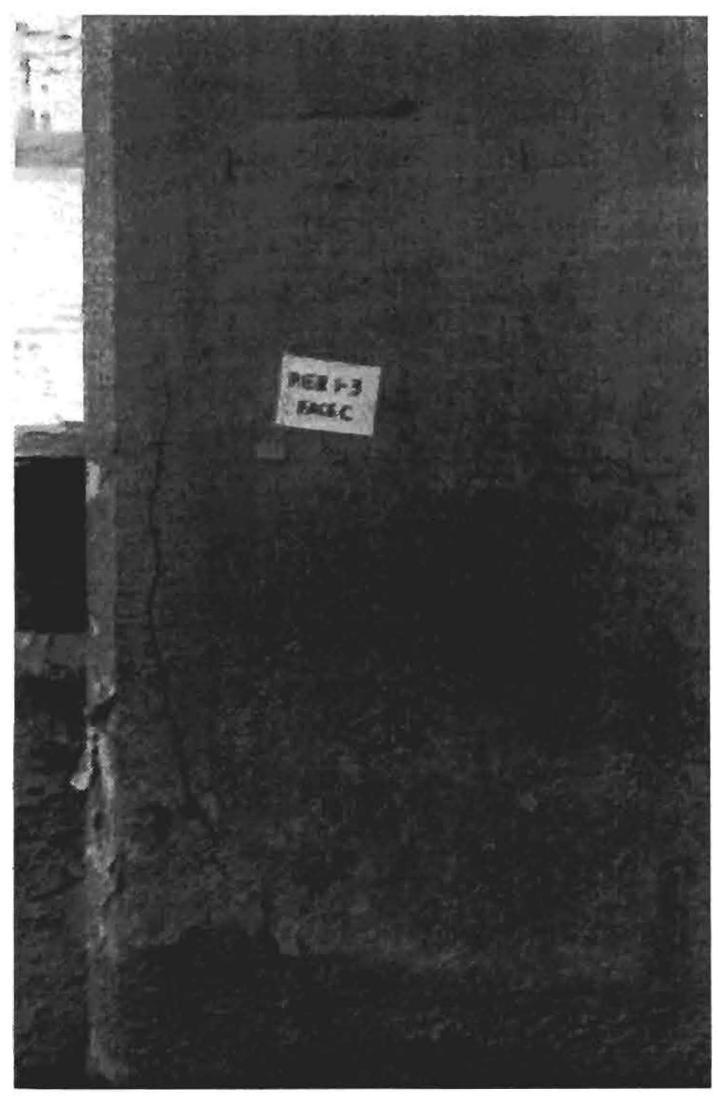
Apart from the isolated cases of corrosion damage sustained by different concrete elements, the piers were subjected to stress-induced cracking, as revealed by the development of numerous well-formed inclined parallel cracks. Evidence of shrinkage cracks was witnessed in all piers and these may have been nucleated with the stress induced cracks to form the final crack imprint. One of the piers appeared to have a small twist at the top due to the rotational displacement of the top slab supporting the kiln. This apparent twisting and the emergence of numerous well-formed diagonal cracks in the pier walls raised the concern of the owner about the structural safety of some of these piers.

Figure 3. Corrosion Damage in Pier.

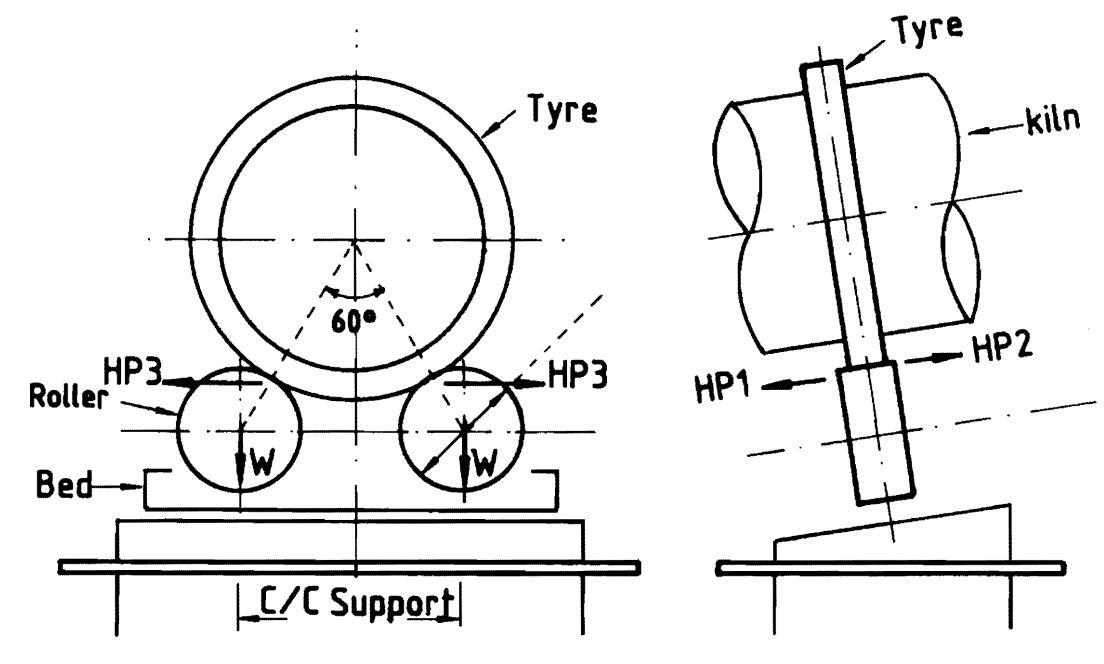
The forces in the three directions, vertical, longitudinal, and traverse, exerted by the rotating kiln on the roller bearings are shown schematically in Figure 4. The nomenclature of the forces shown is as follows:

The case of equal and opposite transverse forces (horizontal thrust) at the rollers when the tyre has perfect contact with both rollers does not have any effect on the pier (Figure 4), as the rollers are supported on a steel bed fixed to the top slab.

Figure 4. Forces Acting on Roller Bearings.

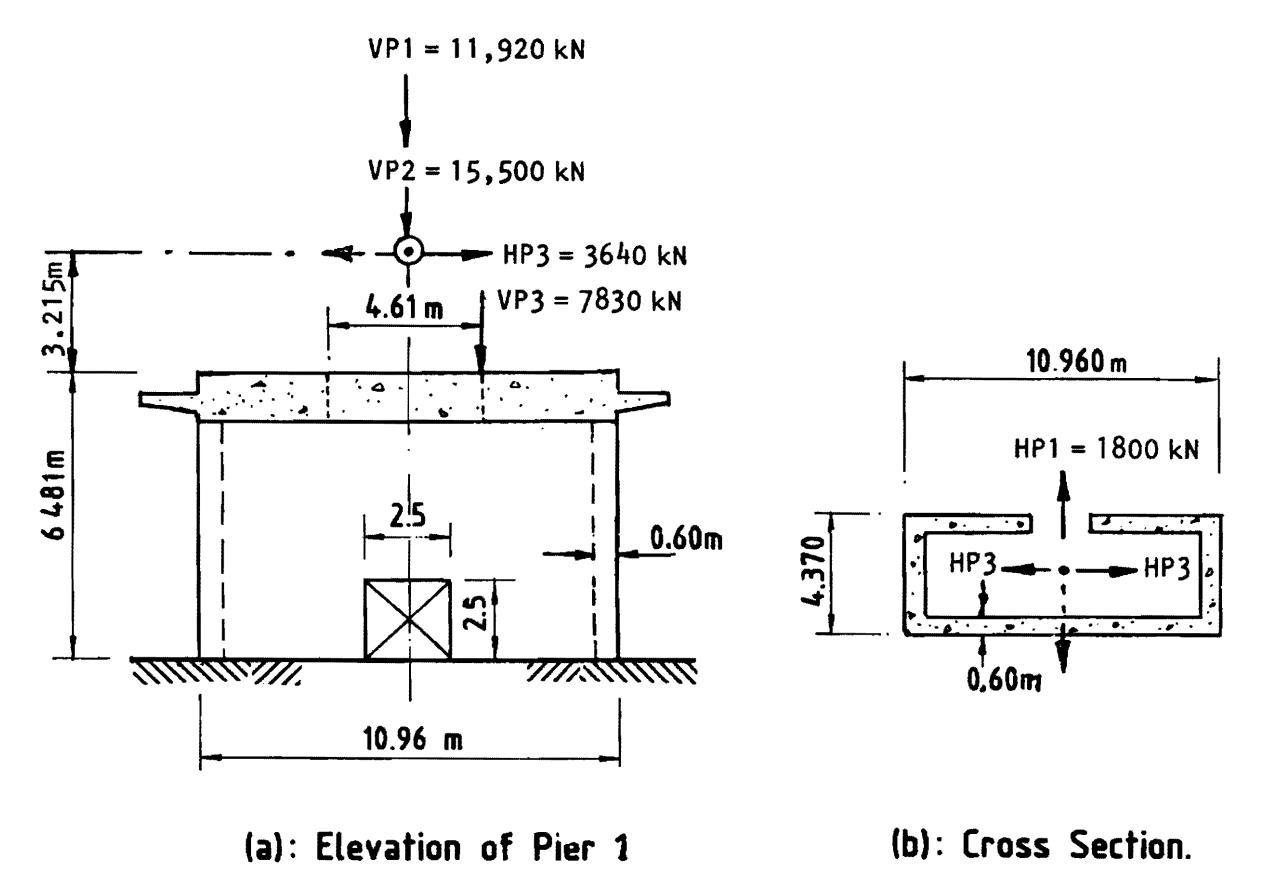
No independent verification of these design loads was made and these prescribed forces were used to check the strength of as-built piers using adverse loading conditions. Pier 1 is subjected to the largest forces among all piers and incidentally is also one of the highly distressed one. Figure 5 shows the location of the forces acting on the pier.

Figure 5. Forces Acting at Pier 1.

A pier is subjected to the combined action of axial compression and biaxial bending under normal condition. However, the consideration of some loss of contact of one tyre and the possible constructional discrepancy in the horizontal alignment produces torsion. This torsional moment proved to be the most critical, as the resulting combined shear stress from torsional moment and shear force far exceeded the permissible limit.

It was observed from computation that the only structural problem facing the pier was the excessive torsional shear stress arising from a consideration of some loss of contact with one roller. Although the magnitude of the twisting action cannot be estimated with a sufficient degree of reliability and accuracy, the presence of a twisting action due to the dynamic action of the revolving tyre, which tends to deliver uneven contact forces to the rollers, was evidently clear from the site observation. It was therefore decided that a certain amount of the twisting action at the top of the pier should be included for a conservative assessment of the strength of piers. Accordingly, a twisting moment of 50% of the maximum possible due to total loss of support contact with one roller was considered in the assessment. The computed torsional shear stress in piers (0.81 MPa in Pier 1) exceeded the permissible limits determined in accordance with the insitu value of f'_c .

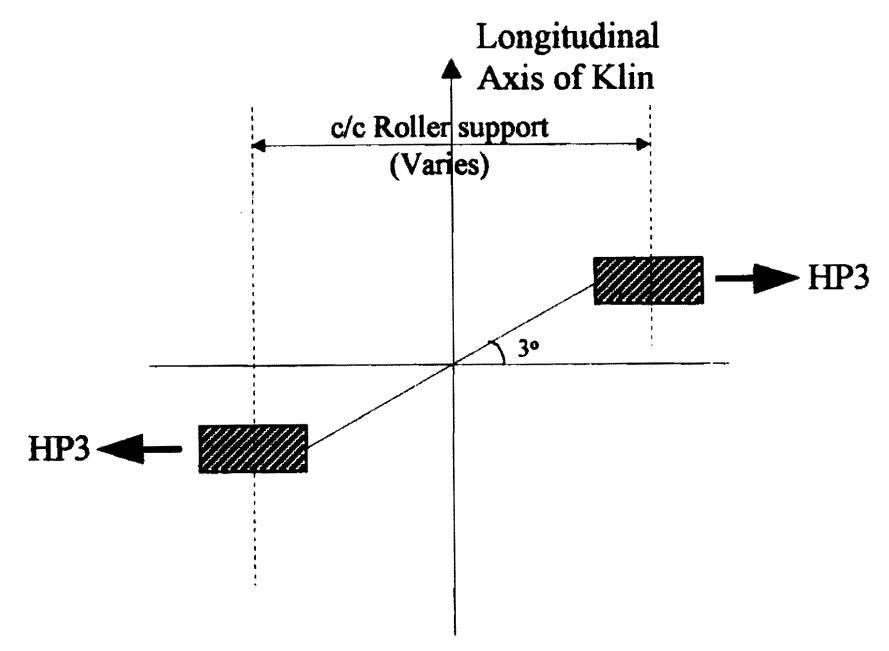
Possible constructional anomalies in the placement of the support bearings may also adversely affect the load actions. An unintended small misalignment or imperfect leveling produces an undesirable amount of twisting at the top of the pier. Evidence of some twisting action at the top of a pier led to this postulation that possible constructional discrepancy which may give rise to torsional moment should be considered in a conservative, safety-conscious assessment.

A careful examination of the operating conditions and input from the owner convincingly implied that the extreme case of a total loss of contact of one tyre is highly improbable, as the kilns have been operating perfectly with both tyres in contact with the rollers. This led to the conviction that only a partial loss of contact is conceivable, and should therefore be considered, by assuming that the tyres do not exert equal forces on the two rollers while rotating. It was decided to consider, as the worst possible case, 50% of the torsional moment which would occur if the tyre has a complete loss of contact with one tyre during operation. Additionally, in order to account for the adverse effect of a small constructional discrepancy in the horizontal alignment of the bearings, a possible error of 3° in alignment as shown in Figure 6 was assumed. Inclusion of this introduces additional torsional moment due to transverse roller thrust.

Figure 6. Possible Constructional Error in Horizontal Alignment.

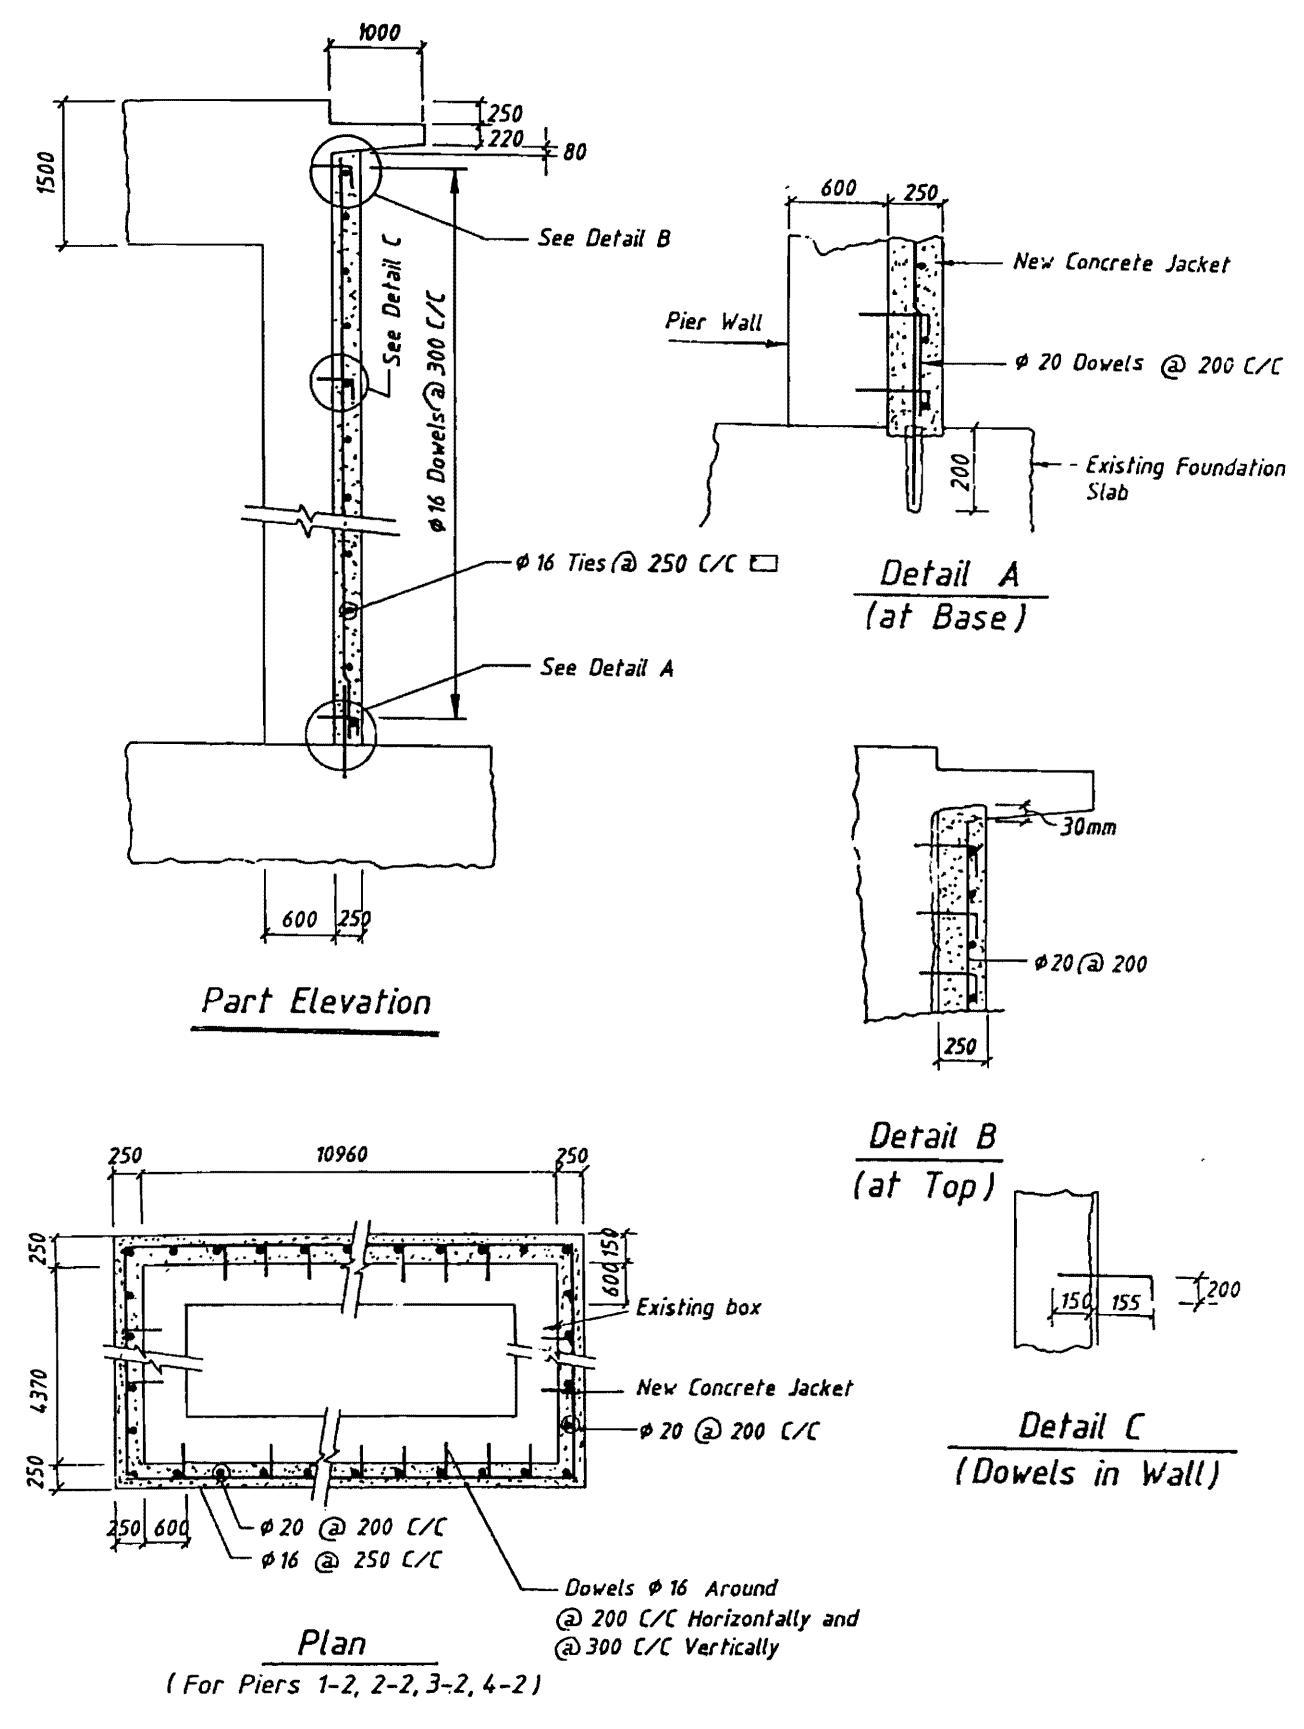
Figure 7. Detail of the Concrete Jacket.

The proposed repair which consisted of installing a new concrete jacket of 250 mm thickness around the exterior face of the box section was found to be the most suitable form of strengthening the piers under hot environmental condition. The details of the concrete jacket and the reinforcement are shown in Figure 7. The reinforcement provided in the wall, both vertical and horizontal exceeded the minimum requirement due to thermal and shrinkage actions.

In order that the new layer of concrete acts integrally with the old concrete with a no-slip interface, dowels of 16 mm diameter bars were installed at a horizontal spacing of 200 mm and a vertical spacing of 300 mm. This stitching of the old and new layer together by dowels ensures adequate bonding of the two layers.

The L-shaped dowels were inserted into the wall by drilling holes slightly larger in diameter to a depth of 150 mm and then anchoring the dowels within the hole by epoxy- grout. The detail of the dowels is shown in Figure 7. The new jacket was also anchored into the foundation slab by inserting dowels of 20 mm diameter into the drilled holes on the top of the foundation slab and then filling-in the holes with epoxy grout.

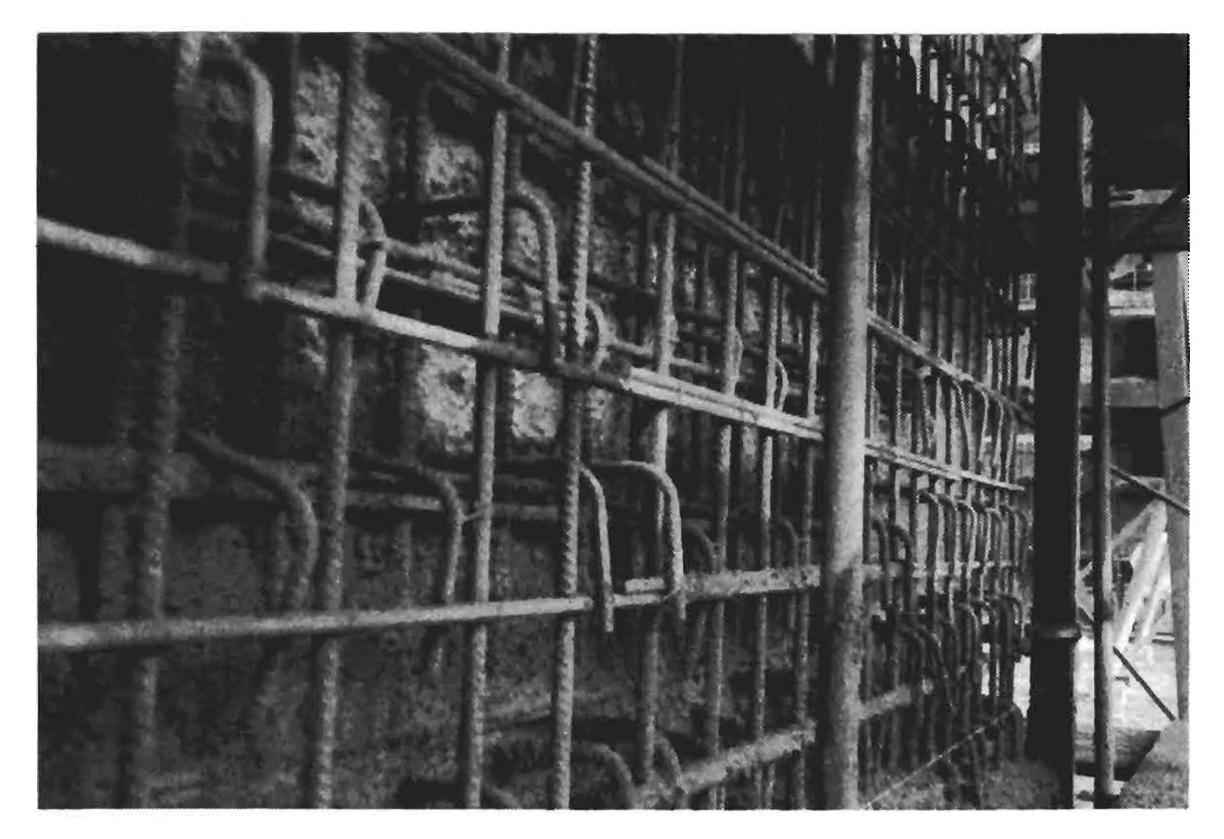
Figure 8. Embedded Dowels in a Pier Wall.

The holes for dowels were drilled into the walls and the foundation slab by using hand-held percussion drills, avoiding the reinforcement in the walls. To avoid oozing out of the grout from the hole, the holes in the walls were drilled with a small upward inclination. The holes were cleared of dust by blowing air and then each hole was filled up with heat resistant epoxy grout following which the dowels were inserted into the grout-filled holes (Figure 8). The oozing out of grout ensured that the pocket with the dowel inside was completed filled with grout.

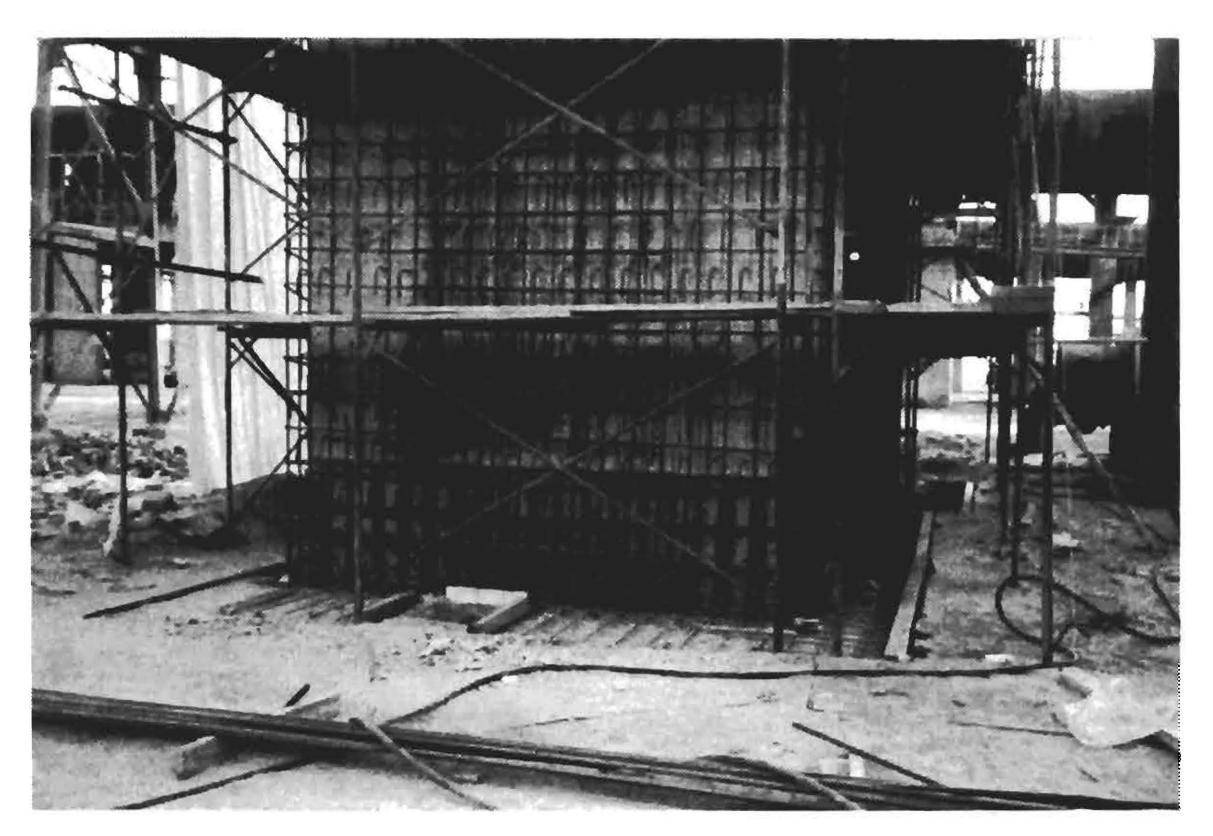
Figure 9. Placement of Reinforcement Around the Pier.

Following the installation of all dowels, the reinforcement for the new jacket consisting of horizontal and vertical reinforcements (Figure 7) was caged around the pier, using dowels as their support (Figure 9). The new concreting was then accomplished by shotcrete using a dry mix. The mix proportions for shotcrete were determined by trial mixes and trial tests conducted on panels. Initial mix contemplated the use of small amount of coarse aggregates of 9.5 mm maximum size to reduce shrinkage characteristics of the mix proportion. However, as the loss of coarser aggregate from rebound was excessive, the maximum size of coarse aggregates was kept at 4.75 mm. The finally adopted mix proportion in a batch was as follows: 245 kg of coarse aggregate (maximum size of 4.75 mm) and 105 kg of fine aggregate, representing a proportion of 70% coarse, and 30% fine for the total aggregate and 100 kg of ordinary Portland cement (Type I). Water–cement ratio was maintained approximately at 0.38, by controlling the water flow at the nozzle. Experienced nozzle men were selected for the work by reviewing their workmanship and skill through a series of prequalification tests [6]. The shotcreting procedure essentially followed the recommendations of ACI 506 R [6].
